Key Lessons from the ExxonMobil Baton Rouge Refinery Isobutane Release and Fire

Incident Date: November 22, 2016

No. 2016-02-I-LA

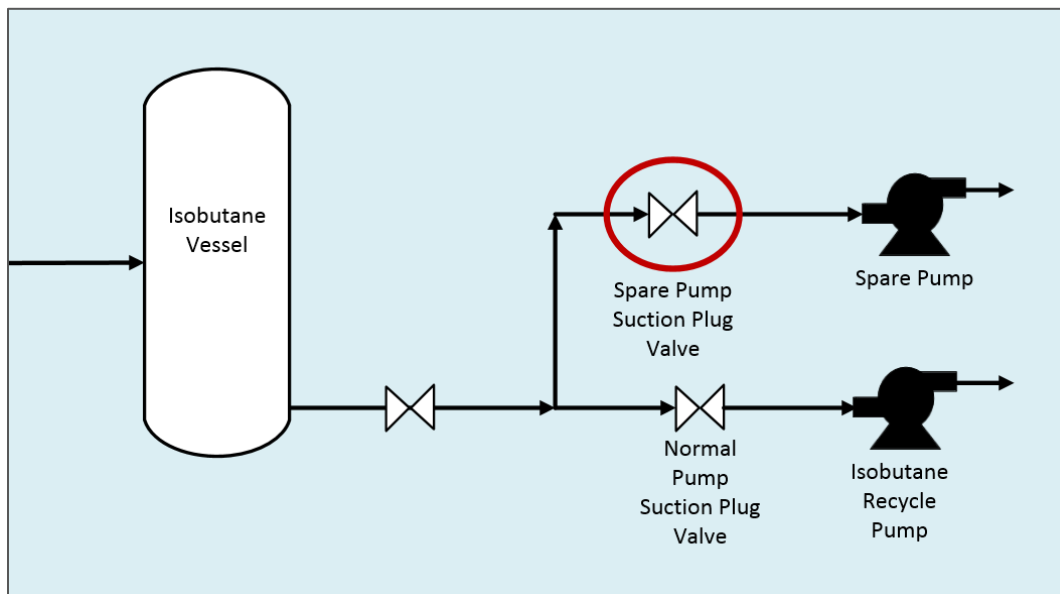
On the afternoon of November 22, 2016, two Baton Rouge refinery alkylation unit operators were preparing isobutane equipment for maintenance.⁶ As part of this preparation, the operators needed to adjust valves to put a spare isobutane pump into service. (Figure 1). To switch the pumps, the operators needed to open the inlet (suction) plug valve to the spare pump. The refinery used a type of valve known as a quarter-turn plug valve for many applications in the alkylation unit, including the inlet valves to these isobutane pumps.⁷

Figure 1. Simplified diagram of the alkylation unit equipment where the release occurred.

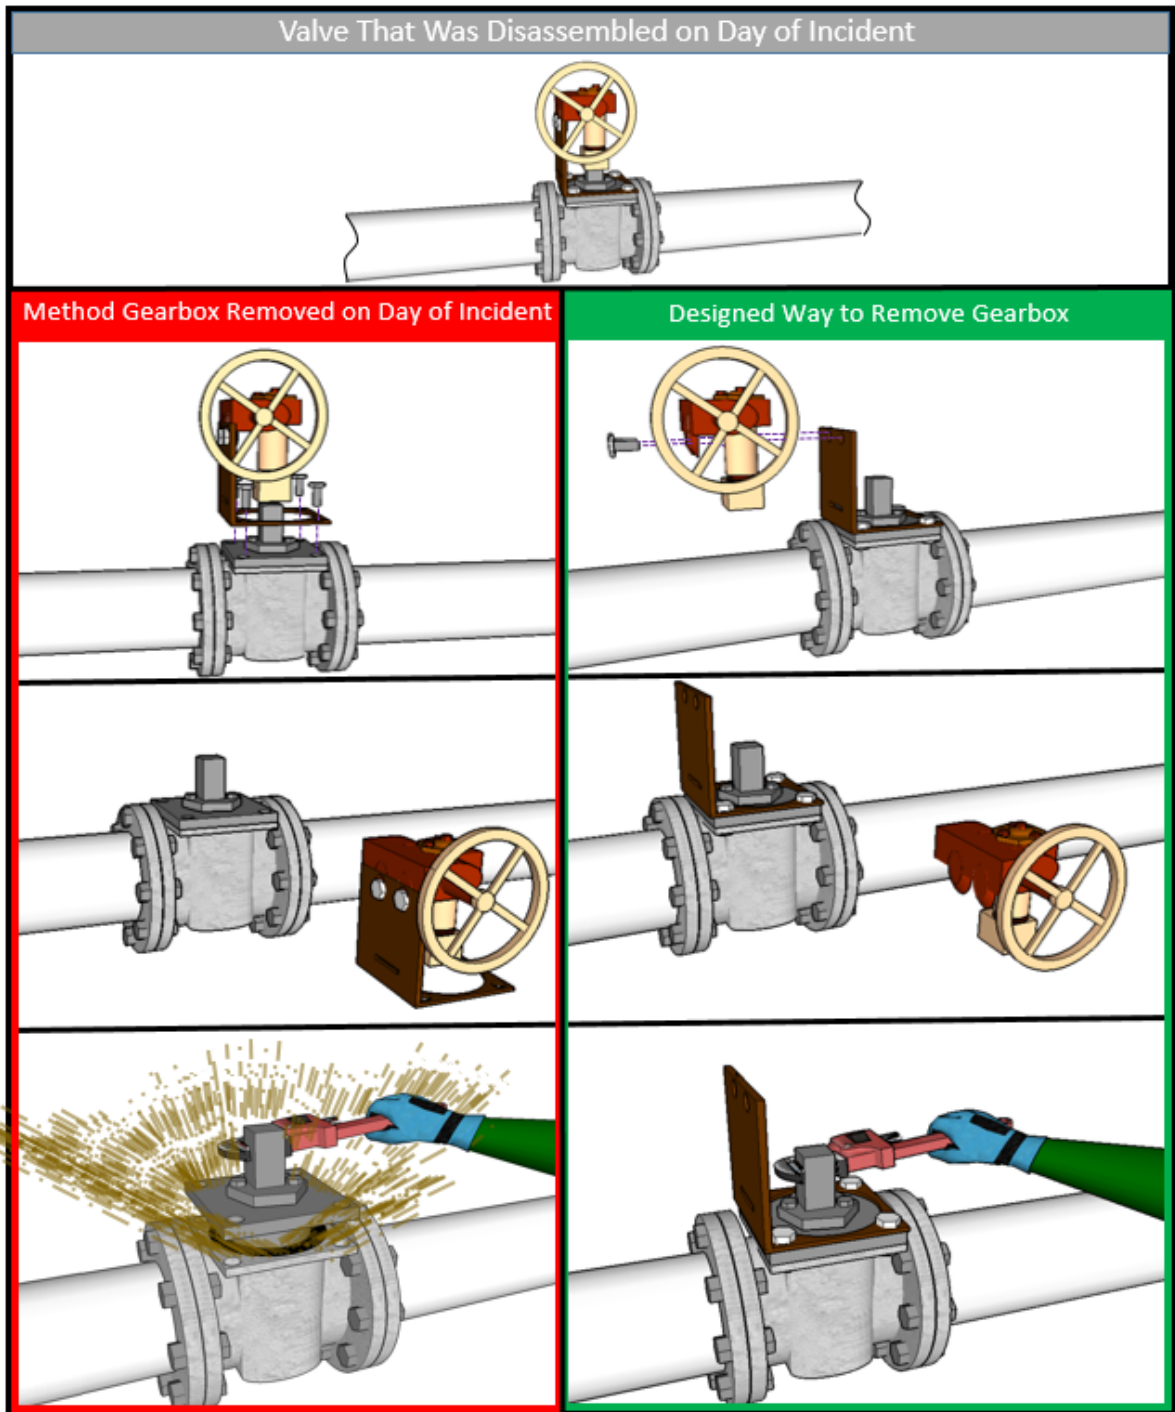
One of the operators removed the gearbox assembly so he could turn the valve stem with a pipe wrench to open the valve.¹⁰ Removing a malfunctioning gearbox from a plug valve is an accepted practice for alkylation unit operators.¹¹ To remove the gearbox, the operator removed the four vertical bolts that connected the gearbox support bracket to the valve body.¹² These four bolts, however, also secured the top-cap – a pressure-retaining component – to the valve body.¹³ The two horizontal bolts that could safely remove the gearbox from the support bracket remained in place. (Figure 3).

One of the operators then opened the valve by rotating the valve stem with a pipe wrench, while the other operator observed. With the four bolts removed from the top-cap, critical valve components were no longer held together. When the operator turned the valve stem, the plug valve loosened and came apart. Pressurized isobutane¹⁴ escaped from the valve body, forming a flammable white vapor cloud.

Figure 3. Gearbox removal. The left column illustrates how operators removed the plug valve gearbox on the day of the incident. It shows operators removed the entire support bracket. By design, removing the gearbox did not require removing the four vertical bolts that secured the pressure-retaining top-cap. The right column illustrates how the plug valve gearbox should be disassembled. The gearbox and handwheel could be disconnected from the support bracket by removing the two horizontal bolts on the side of the support bracket.

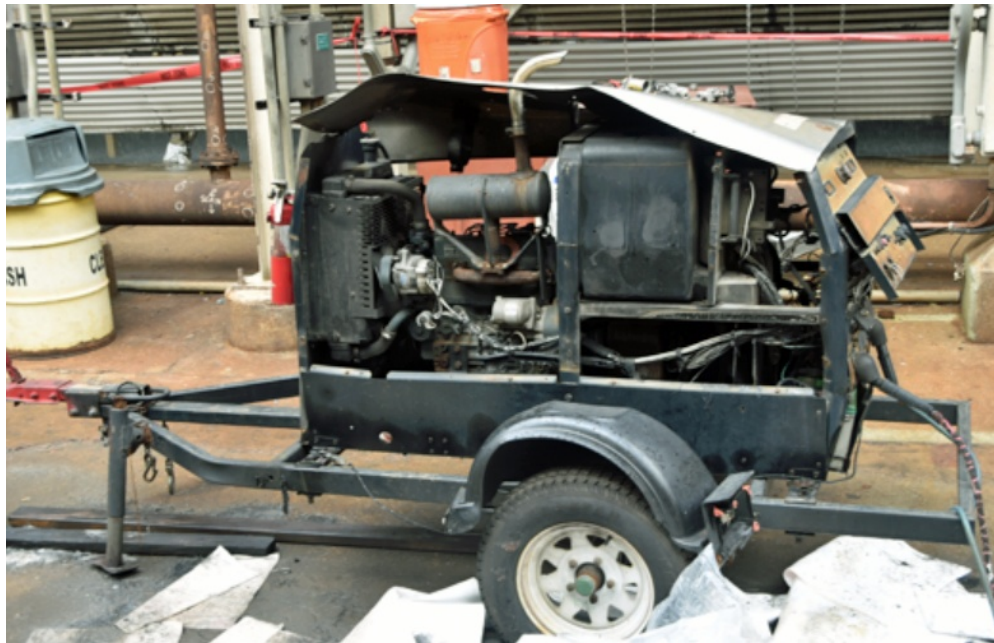
ExxonMobil estimated that 2,000 pounds of isobutane released into the atmosphere. Based on surveillance video, an energized welding machine located roughly 70 feet away likely ignited the vapor cloud. (Figure 4 and Figure 5). The resulting fire seriously injured one ExxonMobil employee and three contractors working in the vicinity of the release.¹⁵ Emergency responders isolated the release and extinguished the fire about 25 minutes after the initial ignition.

Figure 4. Welding machine that was the likely ignition source of the isobutane vapor cloud.

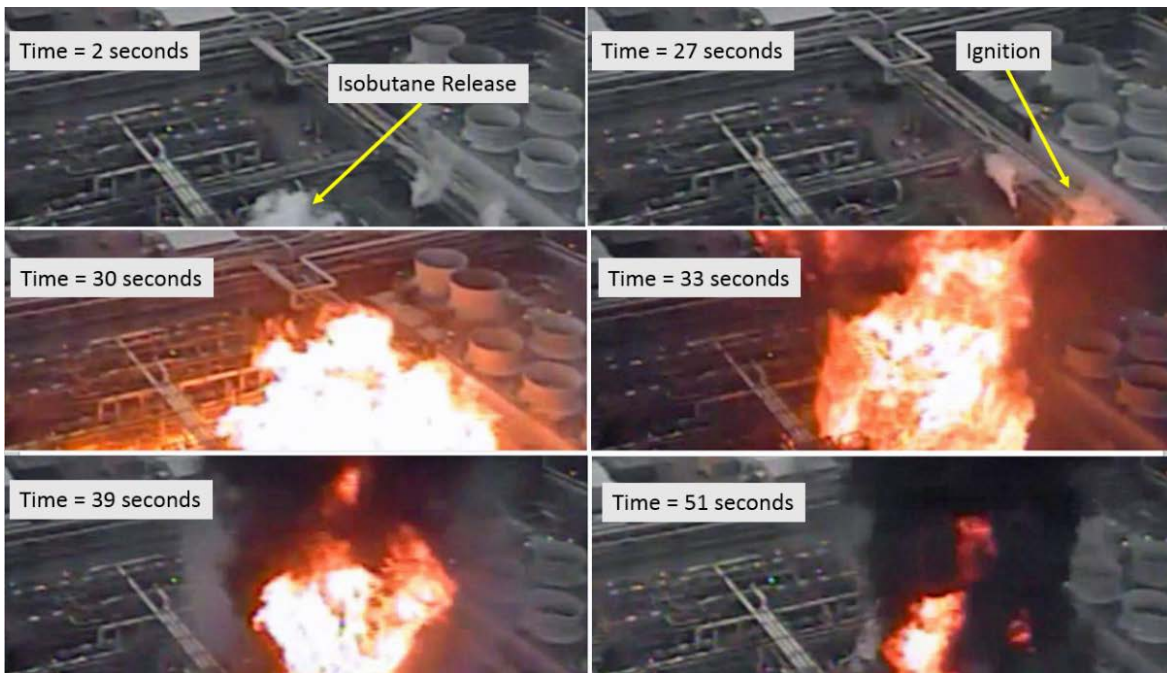
Figure 5. Sequence of events. Baton Rouge refinery security video clips showing the isobutane release and subsequent fire. This sequence does not show time zero – the first indication of the isobutane vapor cloud.

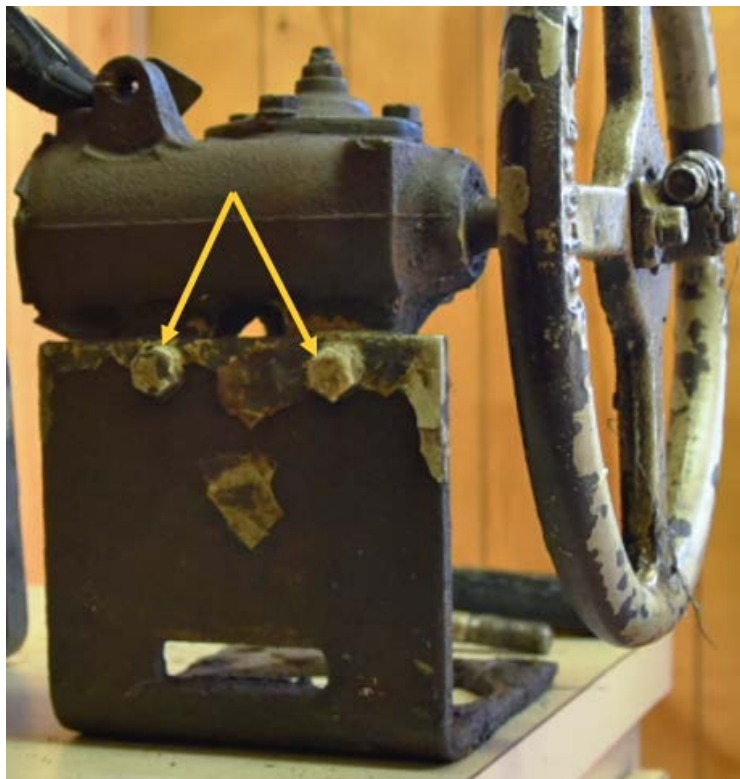
The gearbox involved in the incident conformed to this part of the standard because it *could* be removed without removing any pressure-retaining parts. The operator could have removed the two horizontal bolts that connect the support bracket directly to the gearbox, rather than the four vertical bolts that secure the support bracket to the pressure-retaining top-cap (as shown on the right side of Figure 3 and in Figure 6). But the operator did not remove these two horizontal bolts; instead, he removed the four vertical bolts, which he believed to be the correct bolts to remove.

Figure 6. Gearbox support bracket for the valve involved in the incident. The two horizontal bolts (yellow arrows) can be removed to take the gearbox off the support bracket and the valve without disturbing the top-cap bolts. By removing the gearbox in this manner, the pressure-retaining valve components are not disturbed.

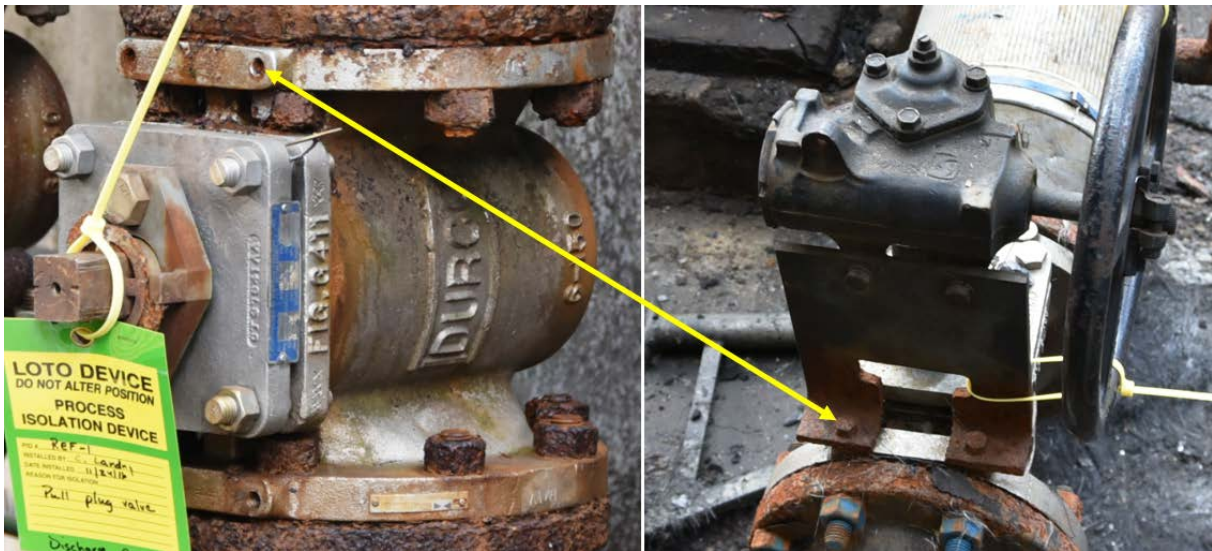
The CSB learned that the plug valve manufacturer (Durco) updated the plug valve design in 1984 so that the gearbox support bracket could be attached to the valve using different bolt connections than those that secure the pressure-retaining top-cap to the valve body. Approximately 97 percent of the plug valves located in the Baton Rouge refinery's alkylation unit are the more recent Durco plug valve design, which secures the gearbox assembly to the valve body flanges. (Figure 7 and Figure 8). With this improved design, the gearbox support bracket is unlikely to connect to the pressure-retaining top-cap, which can help prevent future incidents.

Figure 7. The improved plug valve design includes an additional four gearbox support bracket holes separate from the pressure-retaining top-cap (located on the valve body flanges) as seen at the yellow arrows. The photo on the right shows a gearbox support bracket attached to the valve body flange for a valve that was not involved in the incident. The photo on the left shows a different plug valve in the alkylation unit with its gearbox removed.

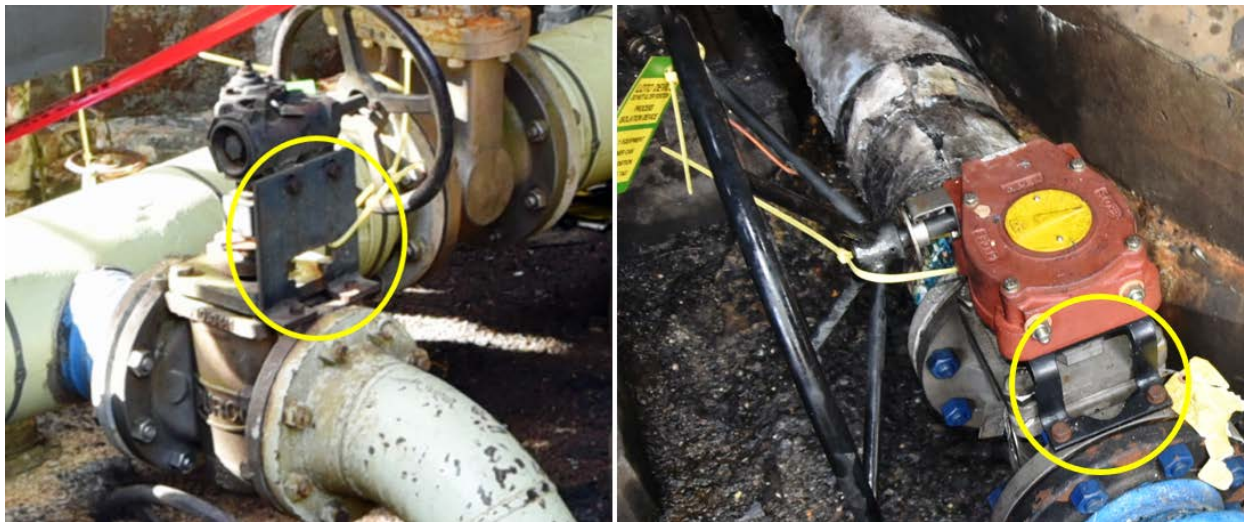
Figure 8. Two of several designs of gearbox support brackets (yellow circles) used at the Baton Rouge refinery. These specific brackets attach to the valve body flange – they are not among the approximately three percent of valves in the alkylation unit that attach the gearbox support bracket using the same four vertical bolts that secure the pressure-retaining top-cap.

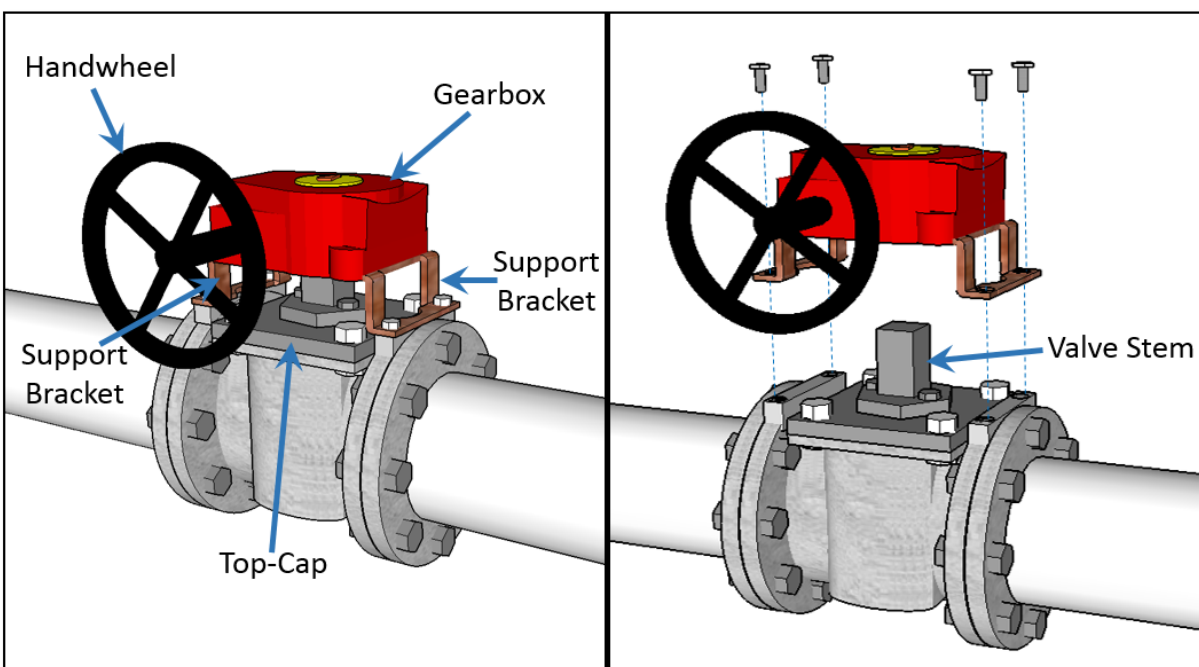
The newer plug valve more broadly used in the alkylation unit is a better design. The redesign addressed the potential to have a chemical release when removing the gearbox assembly. The valve designers provided four additional connection points to secure the gearbox support brackets and these attachment locations are not pressure-retaining components. (Figure 9). With the newer and improved valve design, if a worker completely removes the gearbox and its support bracket(s), a chemical release cannot occur.

Figure 9. The post-1984 plug valve design, showing how one type of gearbox connects to all four dedicated attachment points on the valve flanges that are not pressure-retaining parts.

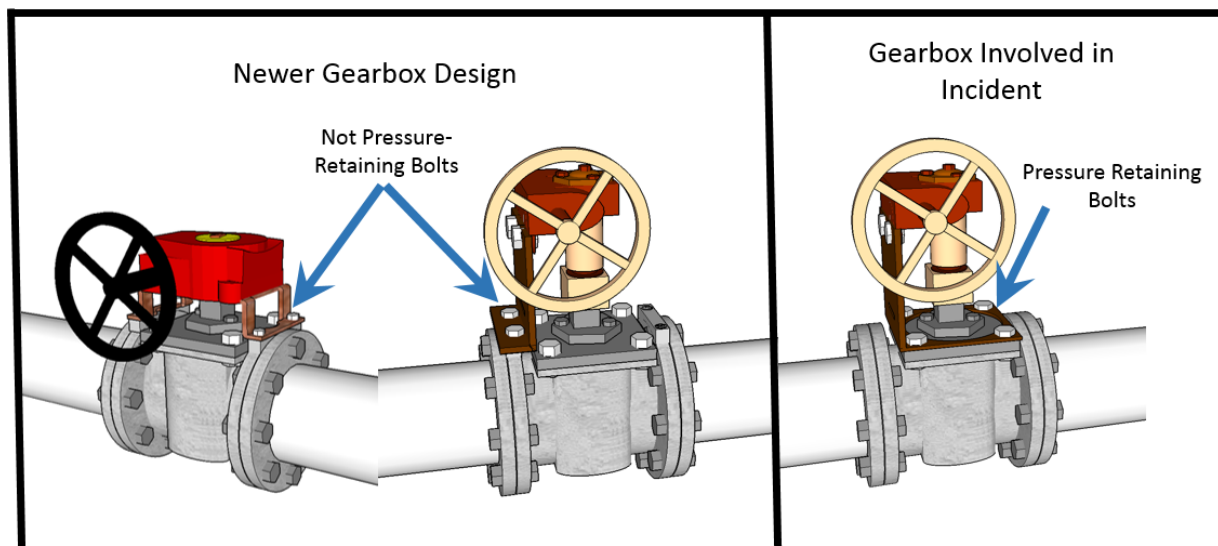
The location of the bolts on the newer valve design may have also contributed to the operator removing pressure-retaining bolts. On the newer design, the bolts connecting the support bracket to the valve are vertical, and are usually removed in order to remove the gearbox and handwheel. In describing how to remove a gearbox from this type of plug valve, an alkylation unit operator explained, “I would only have to pull those [vertical] bolts right there and the whole thing would come off.” Although another operator recognized that there were two different ways to remove the plug valve gearbox, there was not a preferred method. While looking at a photo of a plug valve to explain how to remove the gearbox, the operator said either the horizontal or the vertical bolts could be removed.

For the less common, older valve design, the vertical bolts were the pressure-retaining bolts and should not be removed; instead, the horizontal bolts should be removed to disassemble the gearbox and handwheel safely. (Figure 9 and Figure 10). It could appear as though these critical vertical bolts had to be removed to take the inoperable gearbox off the valve. Although other bolts allowed for gearbox removal without touching the critical pressure-retaining bolts, this design can lead to potentially

catastrophic consequences. The CSB concludes that poor equipment design was a significant factor that led to this incident.

Figure 10. Comparison of newer gearbox attachment designs, which are among the approximately 97 percent of the gearboxes in the alkylation unit, and the gearbox involved in the incident. Importantly, the improved valve design connects the gearbox support bracket to dedicated connection points on the valve flange as shown in the left illustration.

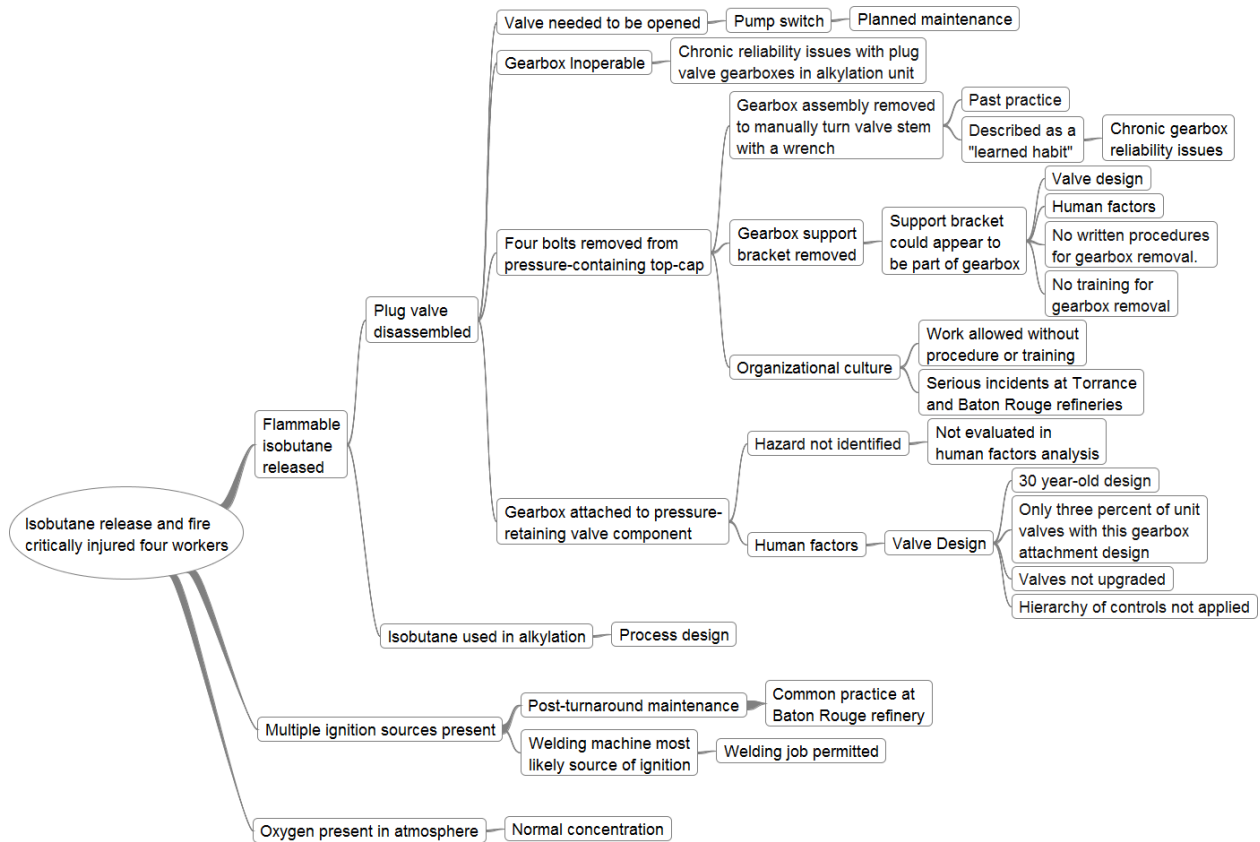
Figure 12. Simplified causal analysis of the November 22, 2016 incident at the Baton Rouge refinery.
